In re Flint Water Cases,
No. 16-cv-1044

Supplemental Report of Dr. Larry L. Russell

October 18, 2022

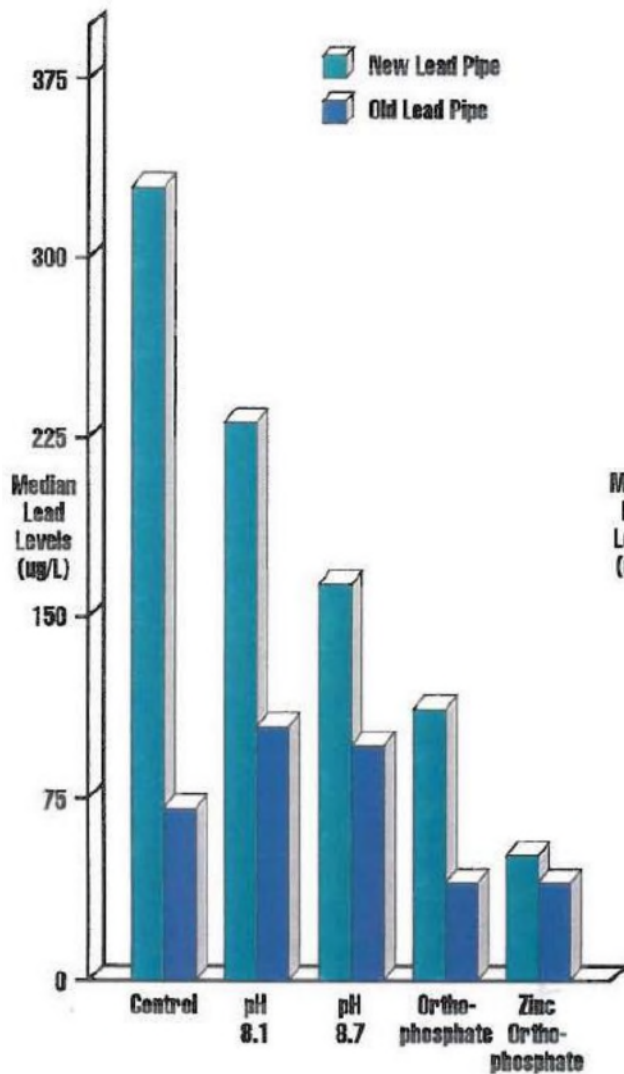
Figure 4.1.4 demonstrates the effectiveness of the chosen chemical addition, Orthophosphate, in controlling lead corrosion with the treated Lake Huron water. Figure 4.1.5 demonstrates the effectiveness of the chosen chemical addition, Orthophosphate in controlling copper corrosion with the treated Lake Huron water. After a substantial pipe loop testing of these alternatives, the TYJT team correctly recommended a treatment strategy using phosphoric acid to add orthophosphate at a recommended dose of 1.2 mg/L as P, initially, and reducing it to a sustained dosage of 0.4 mg/L, as the optimal DWSD corrosion control treatment in their 1994 study (ES-9).

Figure 4.1-4: *DWSD Lead and Copper Corrosion Control Optimization Study (1994)*, Figure ES-5 and ES-6: Measured lead levels from lead pipe (left), brass and soldered copper pipe (right) during corrosion control optimization testing.

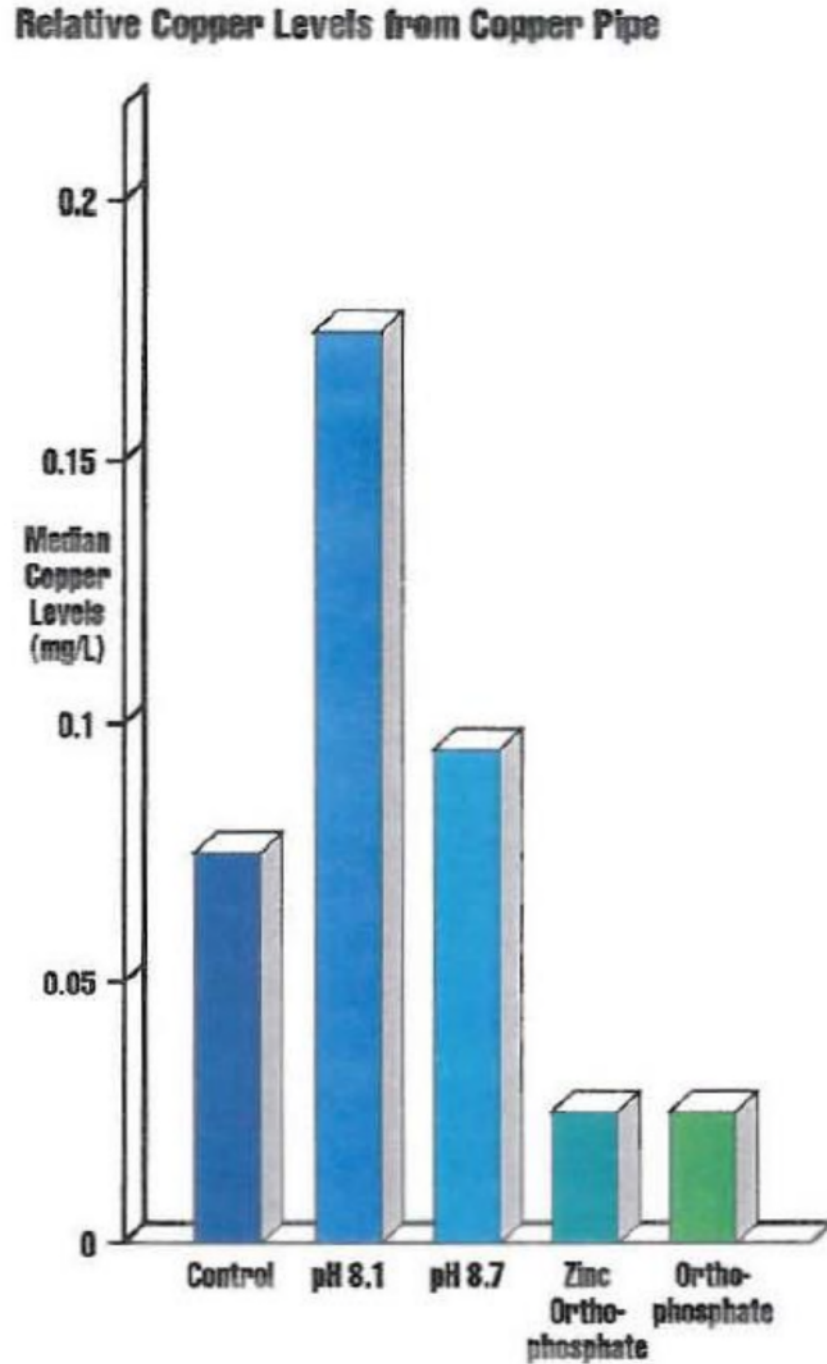
Figure 4.1-5: *DWSD Lead and Copper Corrosion Control Optimization Study (1994)*, Figure ES-7:
Measured copper levels from copper pipe during corrosion control optimization testing.
